Focus on failures: Overlooking the obvious can be costly

Tom Terlizzi

GM Systems LLC
Kings Park, N.Y. 11754
gmsystems.com

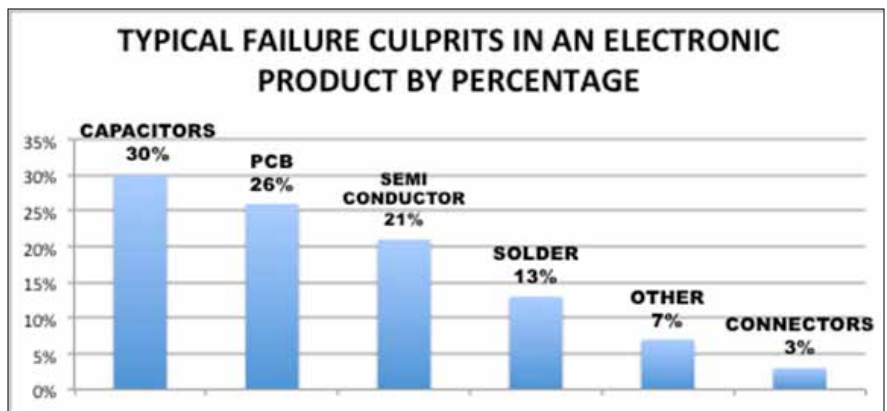
As shown in the figure (at right) there is typically a wide range of “failure culprits” which can occur during manufacture, development testing, and qualification or during use of an electronic product.

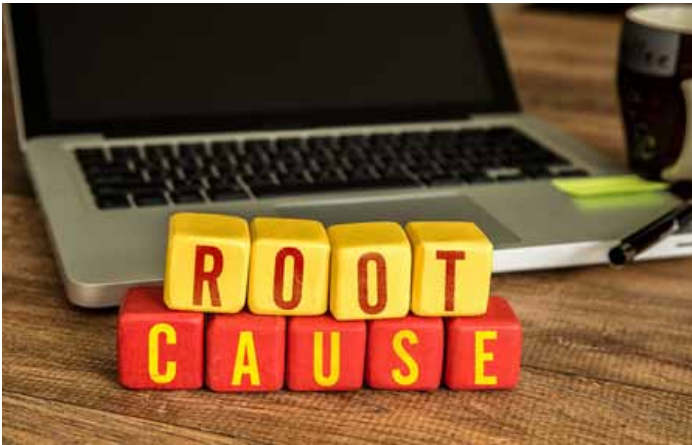
The switch detent plunger is a part of the ignition switch designed to provide sufficient mechanical resistance to prevent accidental rotation. In the faulty ignition switches, the switch detent was insufficient. This al-

The root cause of GM's problems involved the faulty ignition switch not having enough torque, which enabled the ignition switch to move out of the "run" position.
